**Flood Control Project Maintenance
Levee Inspections**

Maintenance Issue Types Only, Levee Inspection Report By Mile - Spring 2019

Reclamation District No. 0369 Libby McNeil

Waterway	Bank	Unit Miles	Inspection Start/End	Inspector
Unit No. 01 Sacramento River	Left	0.78	03/15/2019 03/15/2019	David Julian

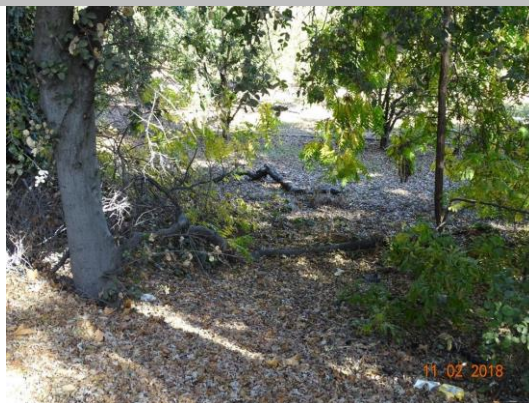
Photo 1 of 1 : SP_2019_RD0369_207_21_20190311_00009.jpg

LM Start	0.13	Rating **	M	Issue No.	21
LM End	0.13	Issue Type +	Ma	Location *	LS
Category	Earthen Levee			GPS Latitude/Longitude	
				Start	End
Item	Encroachments			38.257673 °	38.257673 °
				-121.516052 °	-121.516052 °
DWR ID	DWR_RD0369_01_f_2018_21				
Comment Code					
TR : Tree or limb					
Inspector Comment					
Remove tree limb from the landside slope.

View of tree limb on the landside slope (November 2018).

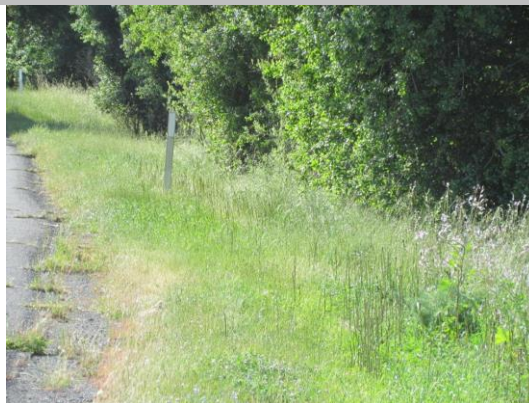
Photo 1 of 1 : SP_2019_RD0369_207_9_20190311_00003.jpg

LM Start	0.25	Rating **	A	Issue No.	9
LM End	0.57	Issue Type +	Ma	Location *	WS
Category	Earthen Levee			GPS Latitude/Longitude	
				Start	End
Item	Vegetation			38.256372 °	38.252597 °
				-121.514504 °	-121.511130 °
DWR ID	DWR_RD0369_01_s_2017_9				
Comment Code					
V2 : Remove the wild growth other than native grasses from the levee slopes.					
Inspector Comment					
Spray the weed growth along the waterside slope to 20' from crown.

Looking downstream from the waterside shoulder.

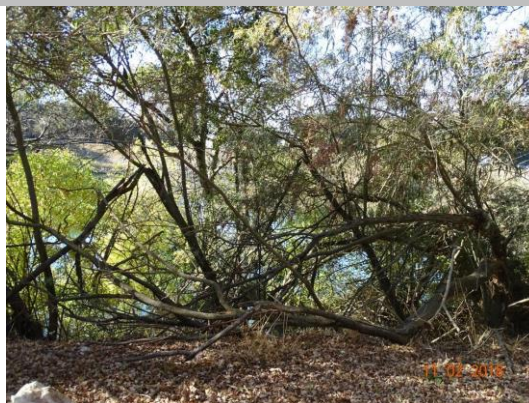
Photo 1 of 1 : SP_2019_RD0369_207_17_20190311_00007.jpg

LM Start	0.27	Rating **	M	Issue No.	17
LM End	0.27	Issue Type +	Ma	Location *	WS
Category	Earthen Levee			GPS Latitude/Longitude	
				Start	End
Item	Trim / Thin Trees			38.256133 °	38.256133 °
				-121.514162 °	-121.514162 °
DWR ID	DWR_RD0369_01_f_2018_17				
Comment Code					
T2 : Thin trees to allow visibility of the ground and room to flood fight.					
Inspector Comment					
Remove some tree branches to allow better visibility and access.

View of relatively thick tree branches on the waterside slope (November 2018).

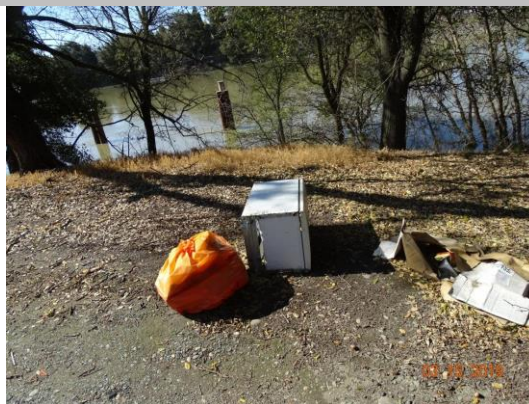
Photo 1 of 1 : SP_2019_RD0369_207_23_20190320_00028.jpg

LM Start	0.30	Rating **	M	Issue No.	23
LM End	0.30	Issue Type +	Ma	Location *	WS
Category	Earthen Levee			GPS Latitude/Longitude	
				Start	End
Item	Encroachments			38.255880 °	38.255880 °
				-121.513865 °	-121.513865 °
DWR ID	DWR_RD0369_01_s_2019_23				
Comment Code					
DE : Debris					
Inspector Comment					
Debris on the waterside shoulder should be removed before more debris is put there.

View of debris on the waterside shoulder (Spring 2019).

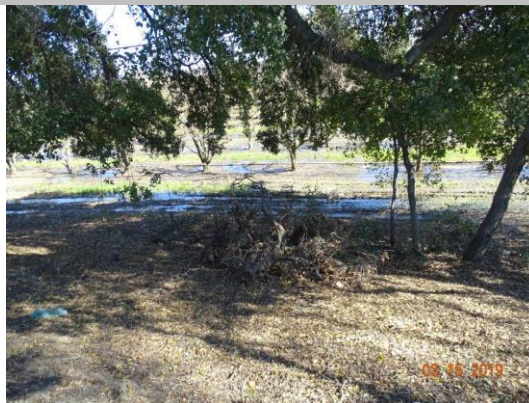
Photo 1 of 1 : SP_2019_RD0369_207_11_20190320_00027.jpg

LM Start	0.35	Rating **	M	Issue No.	11
LM End	0.35	Issue Type +	Ma	Location *	LS
Category	Earthen Levee			GPS Latitude/Longitude	
				Start	End
Item	Encroachments			38.255250 °	38.255250 °
				-121.513207 °	-121.513207 °
DWR ID	DWR_RD0369_01_s_2019_11				
Comment Code					
TR : Tree or limb					
Inspector Comment					
Remove fallen tree limbs from the landside slope.

View of fallen limbs on the landside slope (Spring 2019).

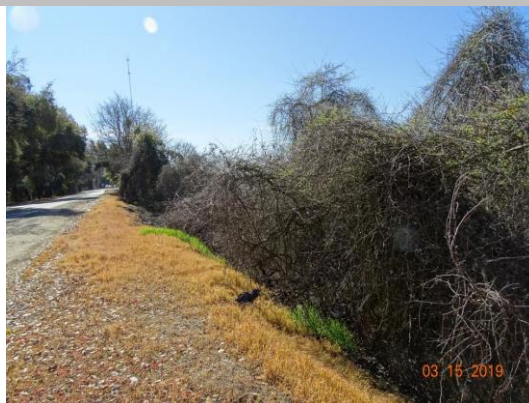
Photo 1 of 1 : SP_2019_RD0369_207_24_20190320_00029.jpg

LM Start	0.41	Rating **	U	Issue No.	24
LM End	0.53	Issue Type +	Ma	Location *	WS
Category	Earthen Levee			GPS Latitude/Longitude	
				Start	End
Item	Trim / Thin Trees			38.254607 °	38.253073 °
				-121.512657 °	-121.511388 °
DWR ID	DWR_RD0369_01_s_2019_24				
Comment Code					
T1 : Trim trees to at least five feet above ground level.					
Inspector Comment					
Trim trees to allow visibility down the waterside slope.

View looking downstream at thick trees on the waterside slope (Spring 2019).

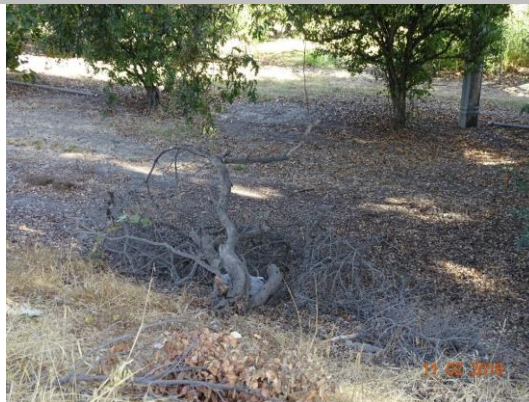
Photo 1 of 1 : SP_2019_RD0369_207_19_20190311_00008.jpg

LM Start	0.52	Rating **	M	Issue No.	19
LM End	0.52	Issue Type +	Ma	Location *	LS
Category	Earthen Levee			GPS Latitude/Longitude	
				Start	End
Item	Encroachments			38.253273 °	38.253273 °
				-121.511505 °	-121.511505 °
DWR ID	DWR_RD0369_01_f_2018_19				
Comment Code					
TR : Tree or limb					
Inspector Comment					
Remove tree limb from the landside slope.

View of tree limb on the land sideslope (November 2018).

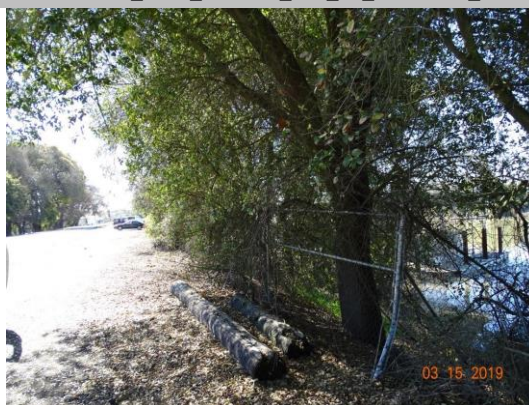
Photo 1 of 1 : SP_2019_RD0369_207_26_20190320_00030.jpg

LM Start	0.57	Rating **	M	Issue No.	26
LM End	0.60	Issue Type +	Ma	Location *	WS
Category	Earthen Levee			GPS Latitude/Longitude	
				Start	End
Item	Vegetation			38.252662 °	38.252247 °
				-121.511138 °	-121.510922 °
DWR ID	DWR_RD0369_01_s_2019_26				
Comment Code					
V2 : Remove the wild growth other than native grasses from the levee slopes.					
Inspector Comment					
Vegetation on chainlink fence is blocking view down waterside slope.

View looking downstream at the chainlink on the waterside shoulder and slope (Spring 2019).

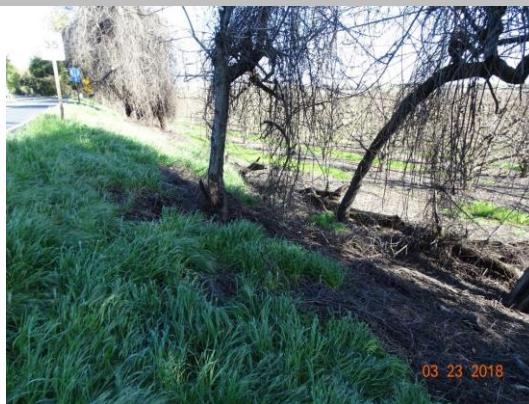
Photo 1 of 1 : SP_2019_RD0369_207_14_20190311_00006.jpg

LM Start	0.58	Rating **	M	Issue No.	14
LM End	0.58	Issue Type +	Ma	Location *	LS
Category	Earthen Levee			GPS Latitude/Longitude	
				Start	End
Item	Encroachments			38.252494 °	38.252494 °
				-121.510961 °	-121.510961 °
DWR ID	DWR_RD0369_01_s_2018_14				
Comment Code					
TR : Tree or limb					
Inspector Comment					
Fallen tree and branches should be removed from landside toe.

Remove fallen tree and branches from landside toe.
